<h1>TEST REPORT</h1>	Report No.	REID-21-06-15-N137
		Date of Issue	June 15, 2021
<h2>Bacterial penetration into the connection part between COWELL® Fixture and Abutment: an <i>in vitro</i> test</h2>

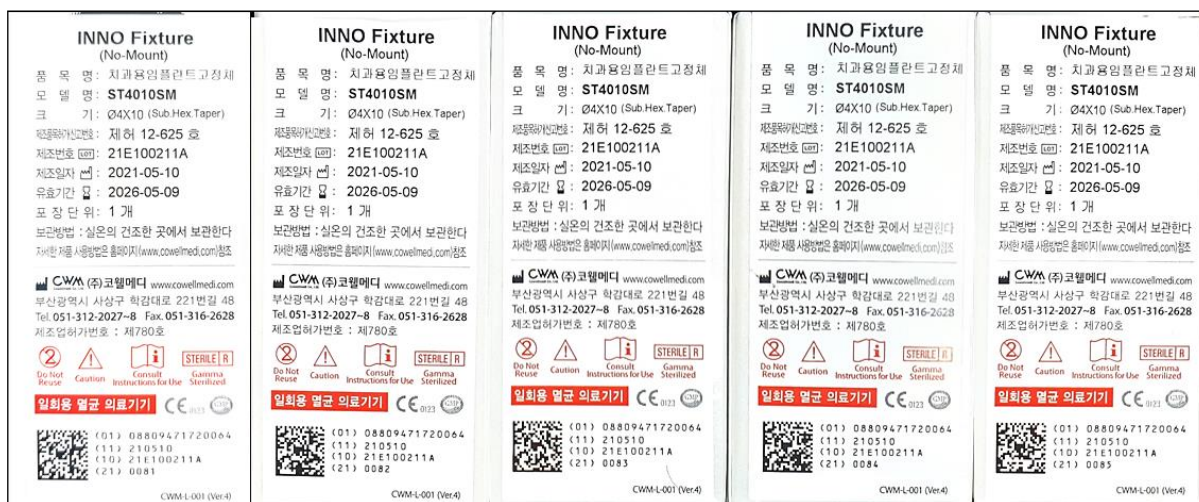
- 3.1. INNO Sub. Fixtures: ST4010SM-21E100211A81 (#1), (Fig. 1).
ST4010SM-21E100211A82 (#2), (Fig. 2).
ST4010SM-21E100211A83 (#3), (Fig. 3).
ST4010SM-21E100211A84 (#4), (Fig. 4).
ST4010SM-21E100211A85 (#5), (Fig. 5).

Fig. 1. #1

Fig. 2. #2

Fig. 3. #3

Fig. 4. #4

Fig. 5. #5

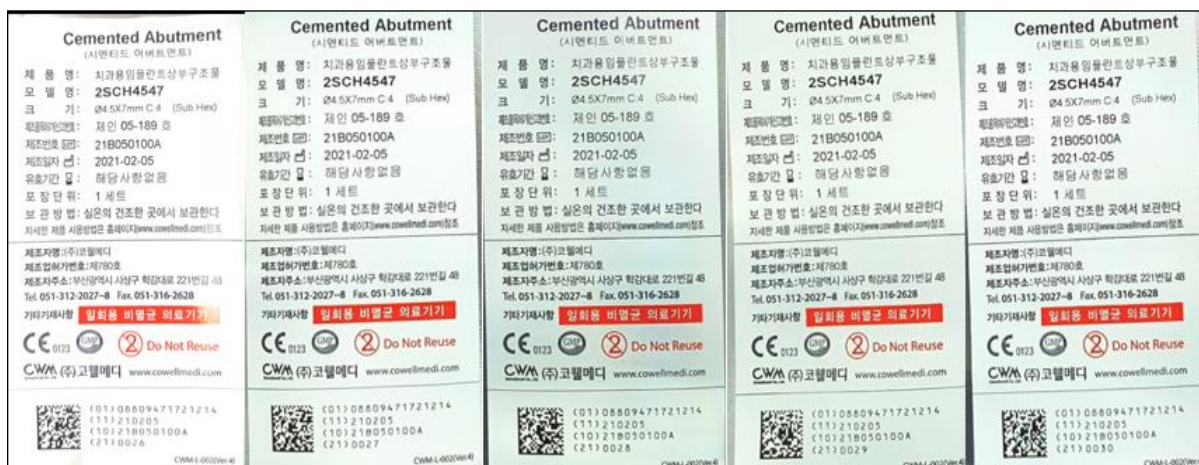
- 3.2. Sub. Cemented Abutments: 2SCH4547-21B050100A26 (#6), (Fig. 6).
2SCH4547-21B050100A27 (#7), (Fig. 7).
2SCH4547-21B050100A28 (#8), (Fig. 8).
2SCH4547-21B050100A29 (#9), (Fig. 9).
2SCH4547-21B050100A30 (#10), (Fig. 10).

Fig. 6. #6

Fig. 7. #7

Fig. 8. #8

Fig. 9. #9

Fig. 10. #10

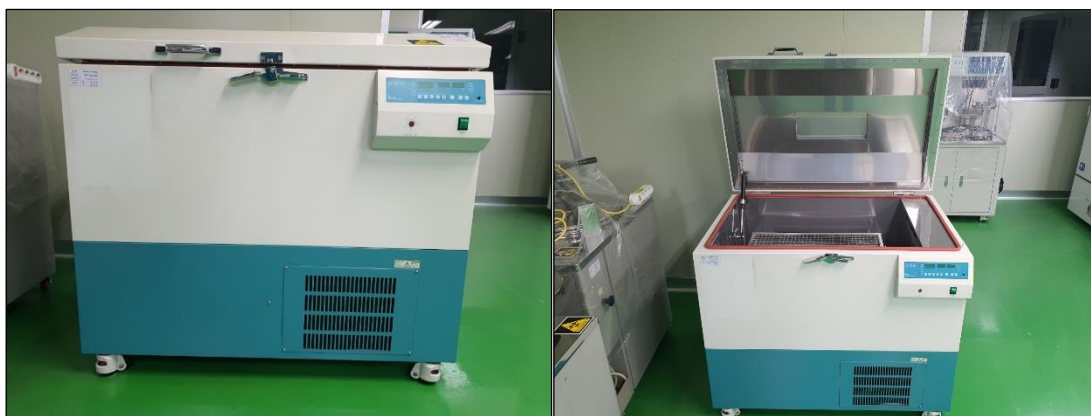
9.1. Shaking incubator (Fig. 12).

9.2. Model number: IS-971R.

Fig. 12. Shaking incubator
